CHEMICAL ANALYSIS TEST REPORT

Product Name : 光學膜

Report No.: HS1804250122A

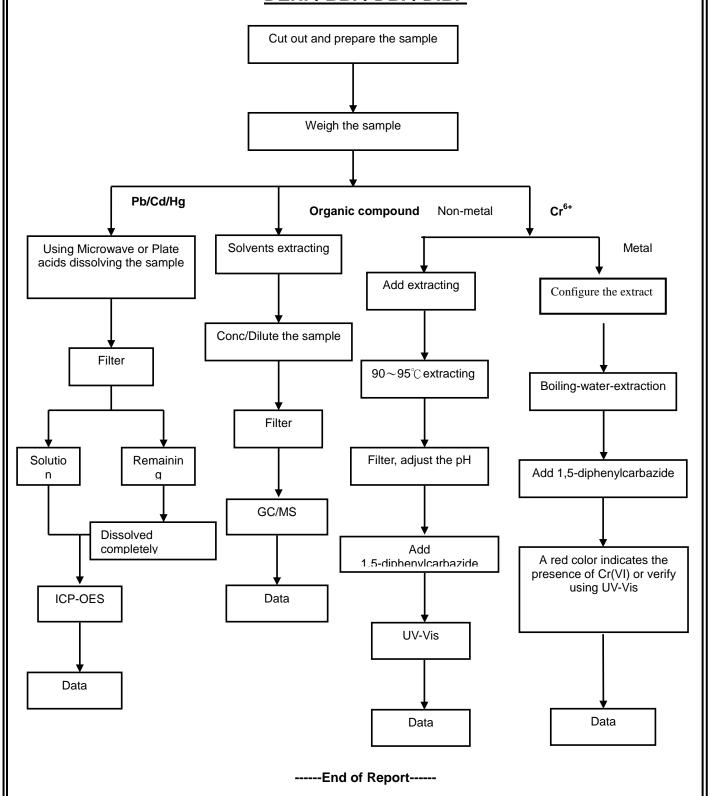
2.3 MEASUREMENT FLOW CHART

Measurement Flowchart of Pb/Cd/Hg/Cr⁶⁺/ PBBs/PBDEs/ DEHP/ BBP/ DBP/ DIBP
